## TEST SUMMARY

## NES M8 CD STUD TENSION TEST

Category	Substrate	Fixing Type	Size	Manufacturer	Part Number	Component Type
Fixing	2mm Weathering Steel	CD Stud	M8	Studfast	M8 x 20 LAW mild steel CD Studs	Preliminary Load Test

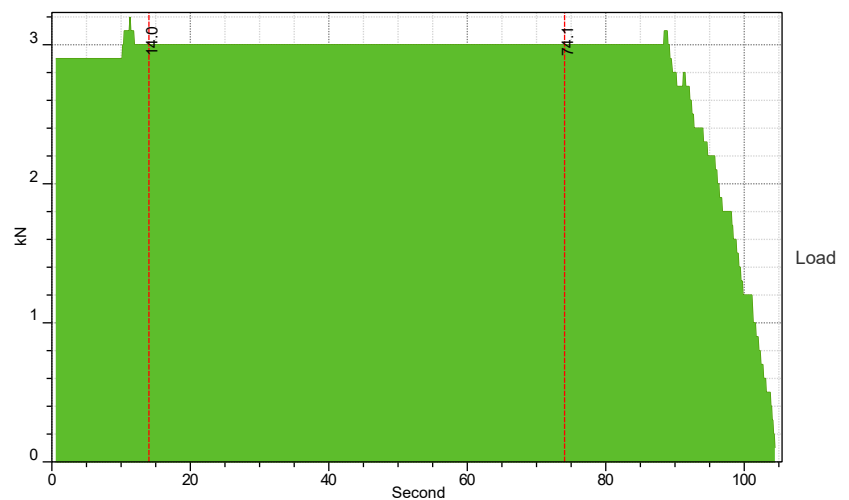
OverTime Chart

Duration	Total Time	Target Load	Load Achieved	Displacement	Reference	Result
1 min	104 secs	3kN	3.2kN		JC95YNL6REZMFE1	Passed

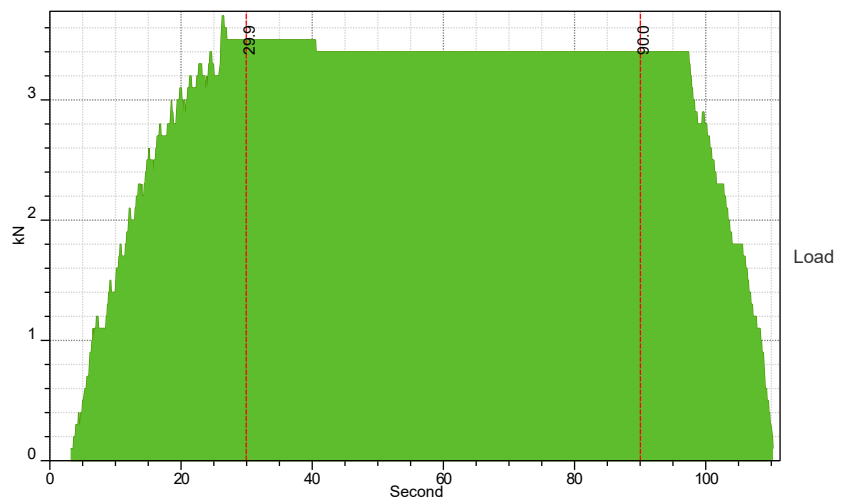
OverTime Chart

Duration	Total Time	Target Load	Load Achieved	Displacement	Reference	Result
1 min	110 secs	3kN	3.7kN		OQ83TTENGJJ1E4	Passed
